PERFORMANCE OF DAMAGE-PROTECTED BEAM-COLUMN JOINTS SUBJECTED TO BI-DIRECTIONAL LATERAL LOADING

SUMMARY

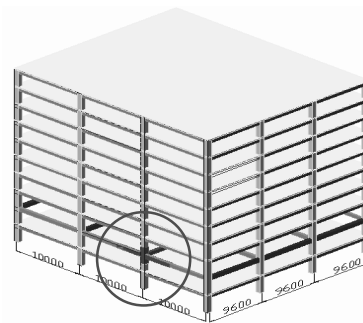
Figure 1: The prototype structure, showing the location of the subassembly.

As shown in Figure 1, the prototype is a ten-storey reinforced concrete frame building with three 10m bays in each direction. This generic structure, commonly known as the “red book” building [15], was designed according to the New Zealand concrete standard [7] for intermediate soil in Christchurch, New Zealand. Keeping all other variables constant, the same structure was designed and detailed according to damage avoidance principles, thereby resulting in precast beams and columns being connected via a post-tensioning system with other devices to provide supplemental energy dissipation. The DAD building was designed with precast flooring units running in the transverse direction and seated on the transverse beams, leaving the longitudinal beams to resist predominately seismic forces.

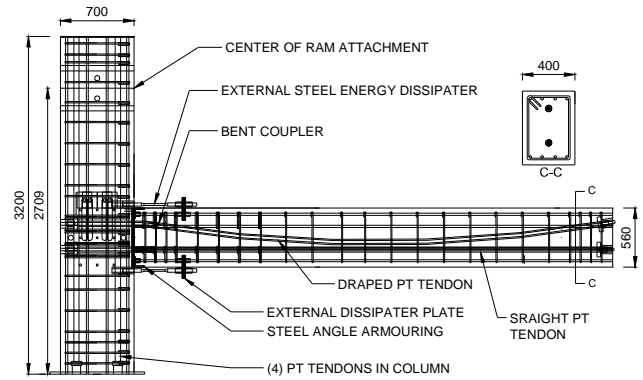
Figure 2: Elevation of the gravity beam and column.

Reinforcing details of the column are given in Figure 2 and Figure 3. An axial load of 2000kN due to self weight of the above floors was simulated in the 700x700mm column by prestressed Macalloy™ 32mm diameter high strength threaded rods. Three 20mm thick mild steel plates were cast at the column faces where precast beams were joined. The minimum reinforcement ratio, $\rho_t = 0.008$ was provided using 12 HD20 threaded bars (Reidbars™). This low reinforcement ratio eased congestion in the joint region. To transfer shear forces through the joint, five double HR12 hoops spaced at 100mm centres were provided. The design compression strength of the column was taken to be $f'_c = 45\text{MPa}$. PVC ducts were placed at a 20 degree angle in each seismic beam and horizontal through the gravity beam for the post-tensioning rods.

Reinforcing details of the seismic beams and gravity beam are given in Figure 2 and Figure 3, respectively. A cracked elastic design was used to detail longitudinal reinforcement in the precast beam segments. In this design approach, sufficient quantities of mild steel are provided to ensure that yield of longitudinal reinforcing is prevented and concrete compressive stresses are below $0.7f'_c$. This ensures precast elements remain essentially elastic even when the connection reaches over-strength. Shear design of the precast elements followed the New Zealand concrete code [7], with a total initial axial load of 400kN provided by the post-tensioning rods. Within the mid section of the beams, only minimal transverse steel was used, thus a stirrup spacing of $d/2$ was adopted. A tighter, 100mm spacing was provided at the ends. Additional stirrups near the joint were provided to provide confinement for the concrete to withstand large compressive stress expected in the end regions.

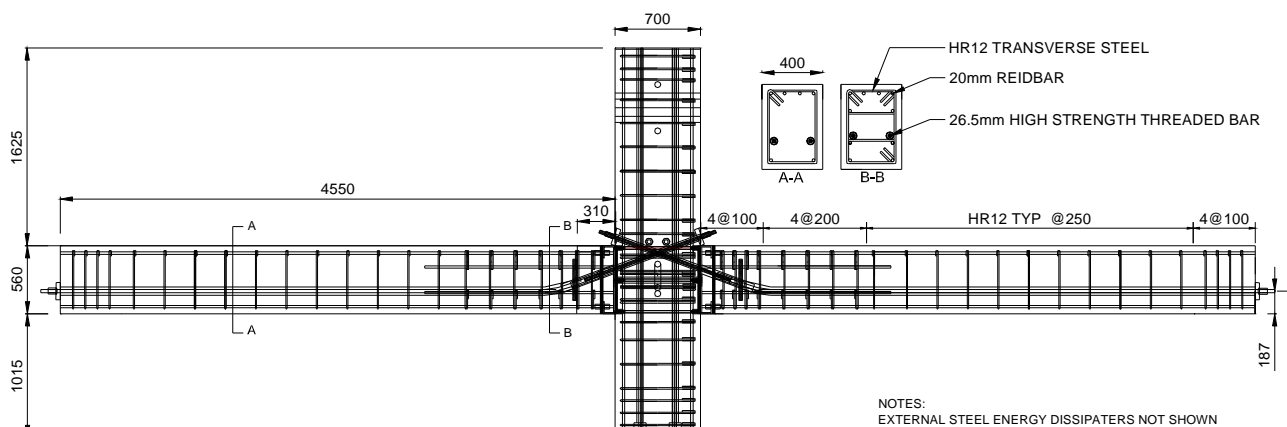
Figure 3: Elevation of the seismic beams and column.

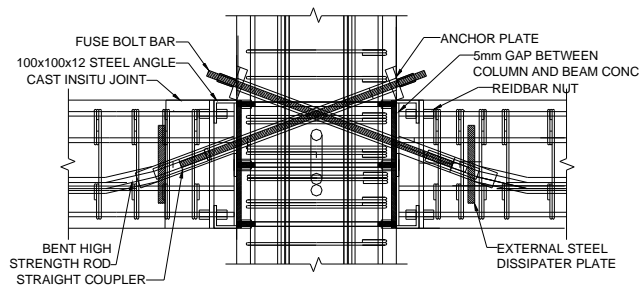
Figure 4: Detail of the seismic beam-column joint.

A detail of the seismic beam-column joint is given in Figure 4. The seismic beams utilized a straight coupler system where the tendons were pre-bent at the joint end to a radius of approximately 1.8m. This allowed proper alignment with the angled rod running through the column. This shorter rod, termed the 'bolt bar', was machined to 75% of its effective area to ensure any yielding in the post-tensioning system would be limited to the replaceable column bolt bar. At the beam end, a 100x100x12 inverted steel angle was used at top

and bottom of the joint and the face of concrete was recessed 5mm. This ensured that contact with the column was limited to the steel and allowed the angle's buried flange to mechanically develop the beam's longitudinal steel using ReidbarTM nuts.

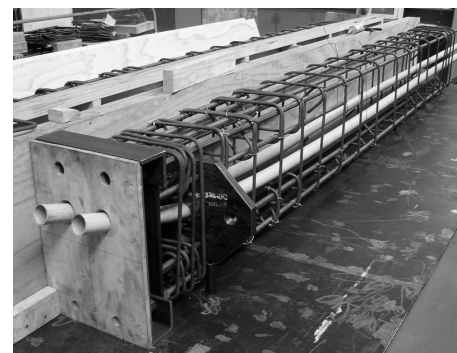
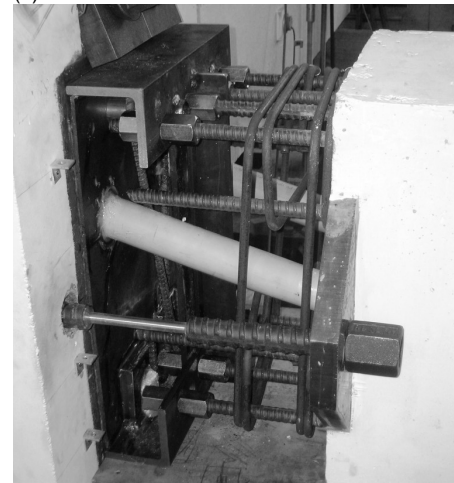
Figure 5: Precast concrete beams showing: (a) the beam cage; and (b) the cast insitu closure pour.

By the nature of precast concrete and rocking connections, it is critical that the face of the beam be aligned flush with the column. Therefore, offsite erection of a full length beam section may lead to on-site misalignment issues which may effect rocking behaviour. To mitigate this and allow for construction tolerances similar to current standards, a 310mm cast insitu closure pour was provided on the west seismic beam. This closure pour is implemented on-site after the armouring angles have been adjusted to ensure a flush face at both ends and the post tensioning rods are coupled together. High strength, fibre-reinforced concrete was used in the insitu end to compare its behaviour to the regular strength concrete of the east beam. The compressive strength of the high strength concrete was tested and found to be $f'_c = 70\text{MPa}$. The east beam and the remainder of the west beam concrete was found to be $f'_c = 37\text{MPa}$. A photograph of the beam prior to pouring and the cast insitu closure pour is given in Figure 5.

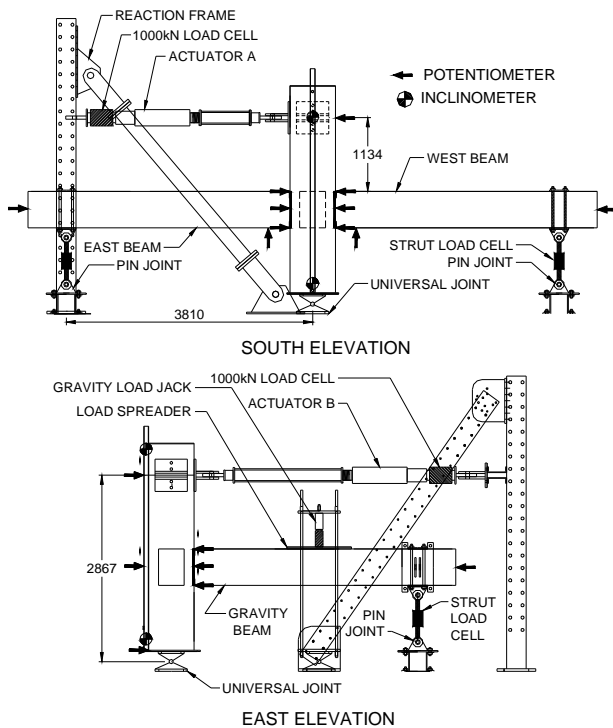
Figure 6: Elevations of the testing apparatus.

Figure 6 presents two elevations of the test setup. Loads were applied to the specimen by three hydraulic actuators. Actuators A and B were installed to the reaction frame and top of the west and south face of the column, respectively. Actuator C (shown in Figure 7) was installed in the east-west direction at the end of the gravity beam. This actuator was intended to keep the specimen movement in-plane during uni-directional testing

and provide a measure of torsion in the specimen. Actuator C's movement was synchronised to approximately one half the displacement of Actuator A. A constant 120kN load was applied at midsection of the gravity beam through a 300kN hydraulic jack, simulating the weight of the precast flooring panels. The load was spread over a 1.5m timber block and developed into the strong floor through four high strength threaded rods. Load cells were installed in series with each actuator. Additional load cells were attached at the strut of each beam and the jacking point of each post-tensioned rod.

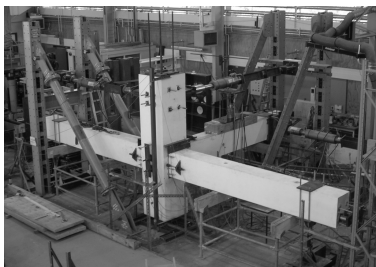
Figure 7: Photograph of the specimen in the testing apparatus.

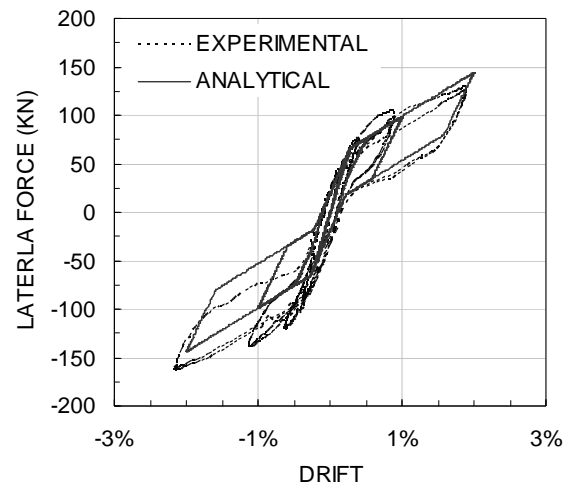
Figure 8: Experimental-analytical response.

A 3D analytical model of the prototype structure was developed using Ruaumoko3D [16], an inelastic dynamic analysis program. Development of this model was part of a parallel study conducted by the authors; details can be found elsewhere [17]. The hysteresis properties of the joint was calibrated based on uni-directional physical testing of the specimen. Figure 8 gives a comparison between the physical and analytical model up to an interstory drift of 2%.

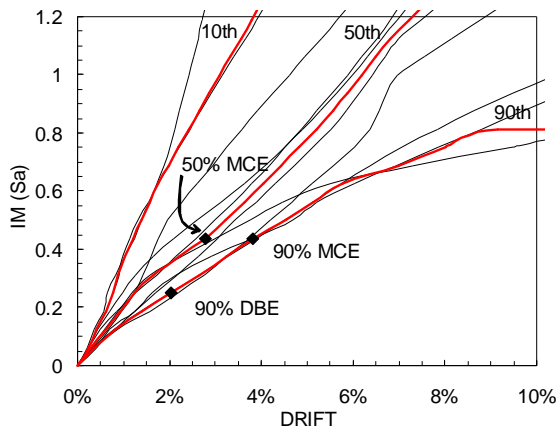
Figure 9: Earthquake record selection for the MSPA, using Incremental Dynamic Analysis.

Current seismological studies predict *peak ground acceleration* (PGA) at various return periods. However, it is not correct to simply apply any earthquake record that conforms to this definition, as structural response is dependent on a multitude of factors. Therefore, it is necessary to extract earthquake records from a suite of likely candidates that will result in the most severe structural behaviour. Such a method has been proposed by Dhakal et al. [13] whereby *Incremental Dynamic Analysis* (IDA) [18] is used to probabilistically determine earthquake records representing multiple performance objectives. This method has been adopted herein and is illustrated in Figure 9. Once an IDA has been conducted earthquake records representing different percentile response at a given *intensity measure* (IM) can be extracted. In this study, records were chosen to yield responses that have non-exceedance probabilities of 90% at the DBE, 50% at the MCE, and 90% at the MCE, from a suite of 40 records consisting of medium and near-source ground motions. The selected records are given in Table 1.

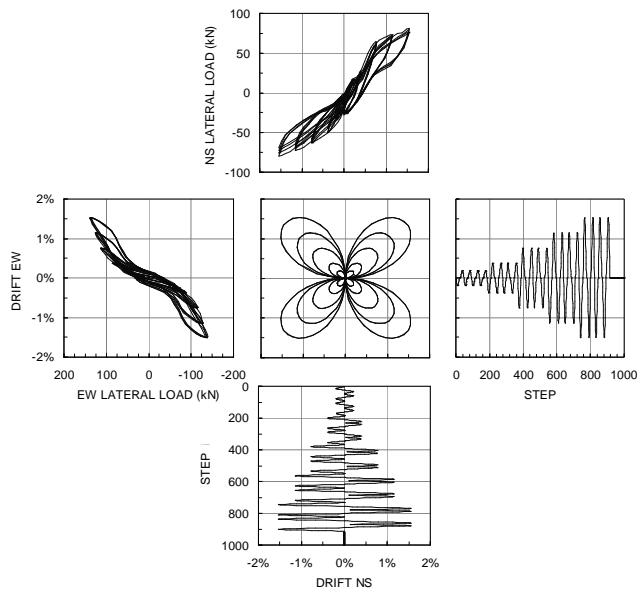
Figure 10: Force-displacement response from bi-directional 'clover leaf' test.

Figure 10 presents results of bi-directional testing to the design level drift of 2%. The results shown are for a bi-directional “clover leaf” test, where total drift is calculated considering both X and Y components. Note that the individual plots are projected to one another, allowing an easy comparison to be made between the NS and EW direction.

As expected, the seismic beam exhibited bi-linear elastic hysteretic behaviour, with some energy dissipation, resulting in a flag-shaped response. Some residual displacement was observed, though this can be partially traced to movement of approximately 2mm in the column base pin, which was repaired for the remaining tests. The unsymmetrical hysteretic response of the gravity beam can be attributed to the inclusion of gravity load, causing an initial positive bending moment at the joint. The gravity beam did not fully re-centre upon removal of the lateral load, resulting in a residual drift of approximately 0.5%. This may be partially attributed to sliding of the base pin.

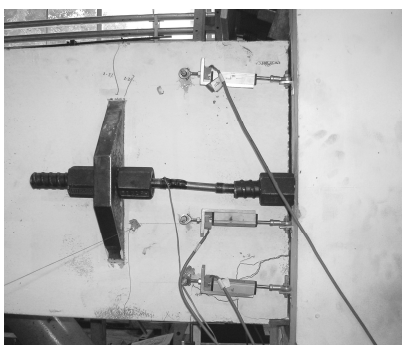
Figure 11: Photograph of the east beam after the bi-directional test to 2% drift.

During stressing of the rods, a 1mm crack formed at the bottom edge of each beam, running between the edge of each flange. This crack can be attributed to the vertical component of the diagonal tendons, approximately a 120kN upward force at the joint. This force in effect pulled the beam up the face of the column. The bottom steel flange however, resisted this due to high friction forces, causing tearing just above the angle, as evidenced by this crack.

Opening of the gap was observed at approximately 0.5% drift, at which point the steel dissipaters yielded in tension almost immediately (as evidenced from strain gauges). In the east beam, two hairline cracks formed just before reaching the target drift of 2%, propagating 100mm out from the dissipater anchor plate. The west beam (high-strength concrete) did not suffer additional cracking. Due to the bi-directional rocking, localised crushing was observed behind the top angle of the east beam over a 10mm square area at the top concrete face. At approximately 1% drift, slight buckling of the steel dissipaters occurred as the gap began to close. This was more severe for the gravity beams than the seismic beams, attributed to their longer length. Throughout testing, no damage was observed on the column. A photograph of the east beam after testing is given in Figure 11.

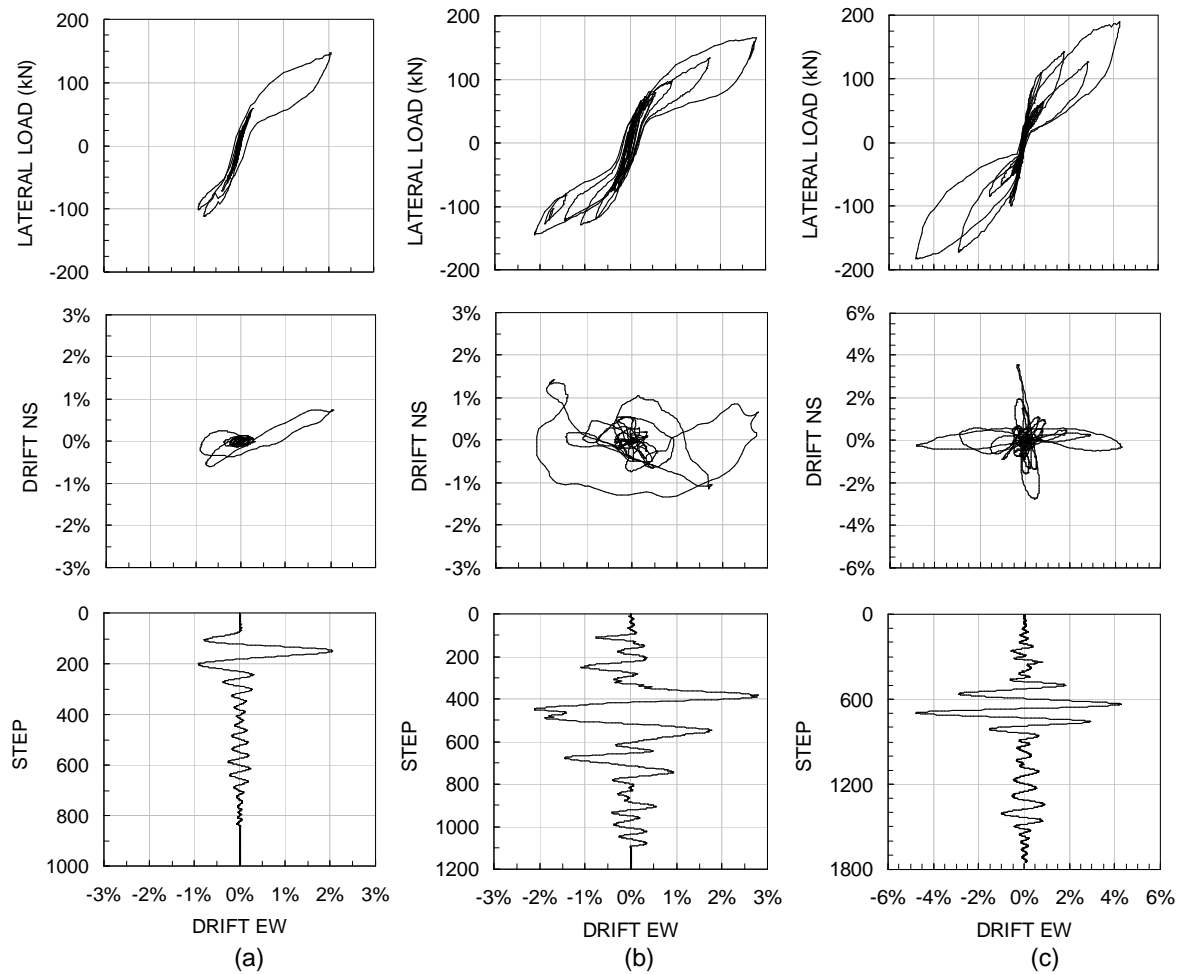
Figure 12: QED test results for the seismic beams (EW direction) for: (a) the 90% DBE; (b) the 50% MCE; and (c) the 90% MCE.

Figure 12 presents results for the seismic beams from the three QED tests. Since the gravity beam had been previously tested as part of a prior study, its response is omitted and can be found elsewhere (Li, 2006). Note that these tests were performed after the initial quasi-static tests (up to 2% drift), and therefore some damage to the specimen had already been observed.

The 90th percentile DBE test consisted of an initial pulse (attributed to the near source record) to the maximum drift of 2.1%. Gap opening and yielding of the energy dissipaters occurred at around the same drift as in previous testing (~0.5%). No new cracks or additional crushing was observed on the seismic beams. A flag shaped hysteresis loop was observed during the initial pulse, however for the remainder of the test response was mostly elastic. Some post-gap opening stiffness degradation was observed, likely due to yielding and buckling of the energy dissipaters. The maximum gap opening, recorded from the potentiometers was approximately 5mm.

The 50th percentile MCE maximum drift was 2.8%, which, like the previous test, occurred in the first major loading cycle. This resulted in considerable yielding of the dissipaters and buckling upon unloading. Consequently, further cycles exhibited a lower capacity, resulting in strength degradation of approximately 20% on the second cycle. A hairline diagonal crack approximately 300mm long was observed on the east and west beam, appearing to be the result of a compression strut. Small (<100mm) hairline cracks formed along the corners of the steel angles of the east beam, but closed after testing. As observed from the strain gauges, the bolt bars reached a maximum of 6000 μ strain ($\epsilon_{yield} \sim 5500$), resulting in slight yielding and an average loss of post-tensioning force of 5%.

The final test, the 90th percentile MCE was the most severe of all tests performed. The maximum drift was 4.7%. Additional crushing was observed along the top and bottom flange of the east beam's steel angle. This crushing was limited to an area of approximately 25mm measured from the flange edge. The bottom flange of the west beam suffered similar crushing, at one end, covering an area of approximately 10mm square. Some spalling was observed over a 25mm area along the angles of both beams. The diagonal cracks formed in the previous test approximately doubled in length and opened to about 1.5mm in the east beam, and 0.5mm in the west beam. At the end of testing, these cracks closed. As seen from the figure, a flag-shaped hysteresis loop was observed, with a maximum residual drift of about 0.1%.

The initial (pre-gap opening) stiffness of the specimen remained virtually unchanged, however. Some minor stiffness and strength degradation was observed in the post-gap opening range. The bolt bars reached a maximum strain of 9000

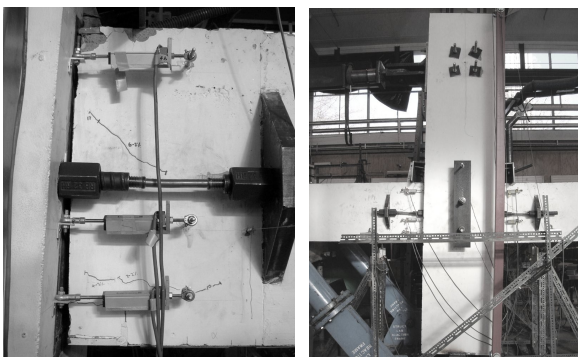
Figure 13: Photographs of the specimen during the 90th percentile MCE: (left) the west beam joint at 4% drift; and (right) the specimen looking south at the maximum drift of 4.7%.

μstrain and maximum force of 360kN, more than the yielding force of the fuse bar. This resulted in a loss of post-tensioning force of approximately 35% and is the major cause of observed strength degradation. Since the yield force of the regular 26.5mm tendon is about 400kN, the bolt bar 'fuse' protected the beam rods from yielding. Two photographs from testing are given in Figure 13.
